Screw Pattern

{ FASTENER APPLICATION }

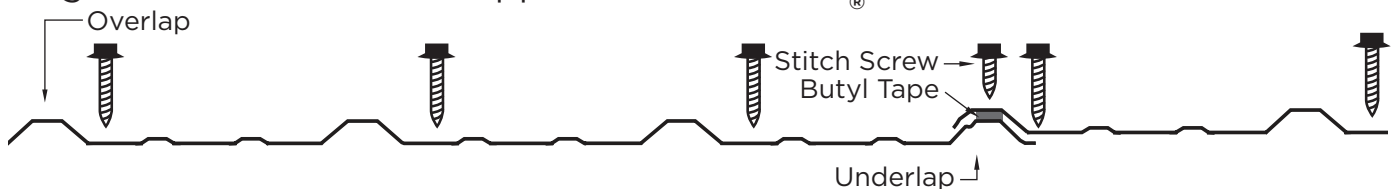
{ High Wind or Low Pitch Application - PR-936® Illustrated }
