## Screw Pattern

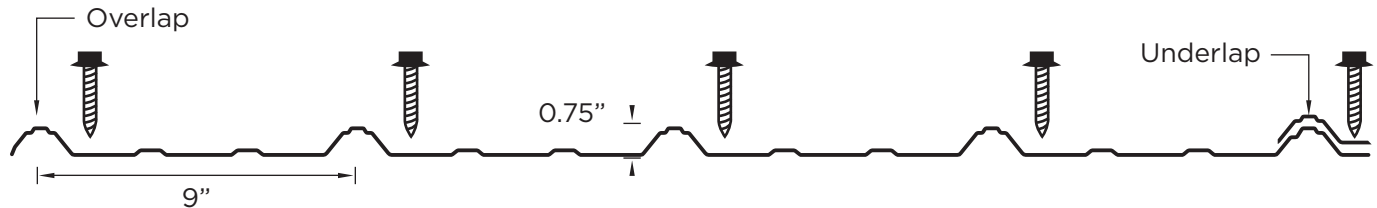
### { TUFF-RIB }

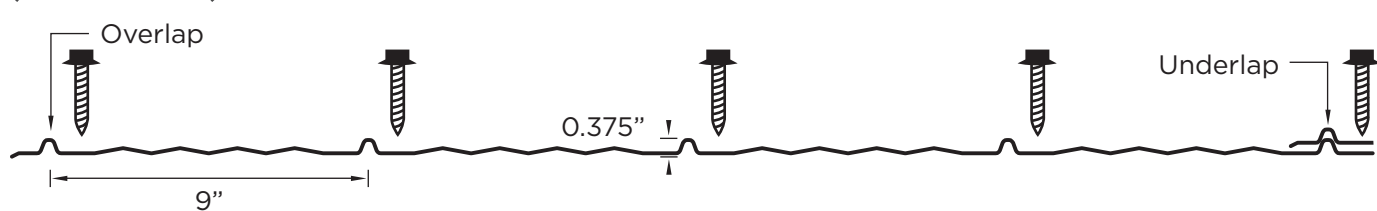
### { LOW-RIB }

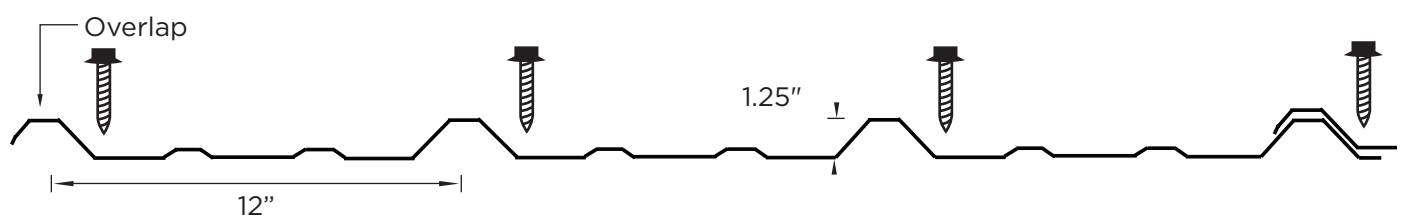
### { PBR }
